**EXPERIMENTAL MAINTENANCE PAINTING
ON THE I-64 RIVERSIDE EXPRESSWAY
IN LOUISVILLE**

**Research Report
KTC-00-10**

June 2000

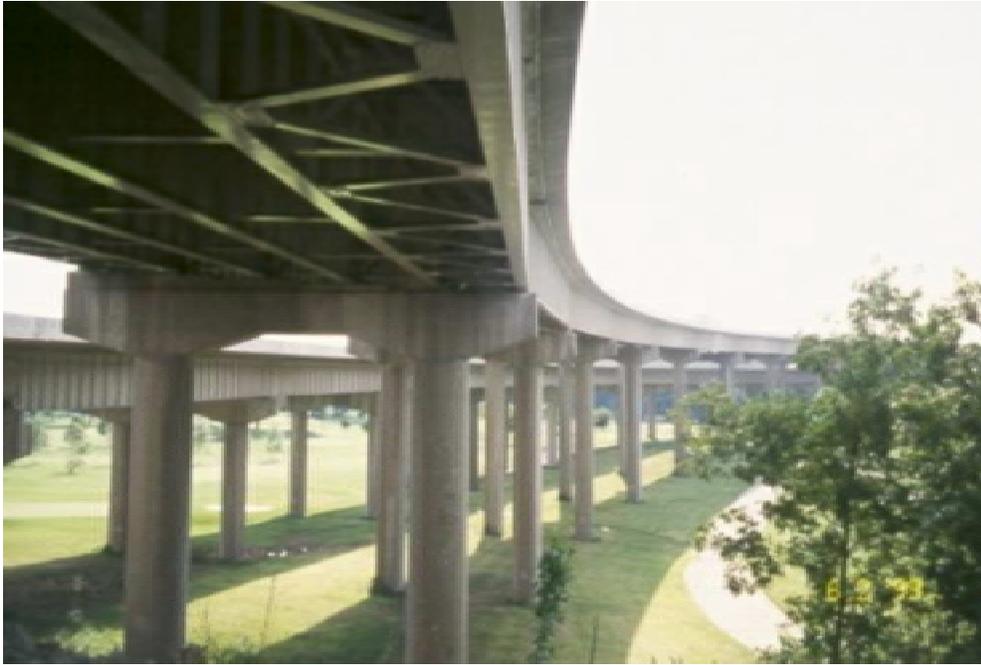
Figure 82. Westward view of span 14 from the east end of structure in 1999.

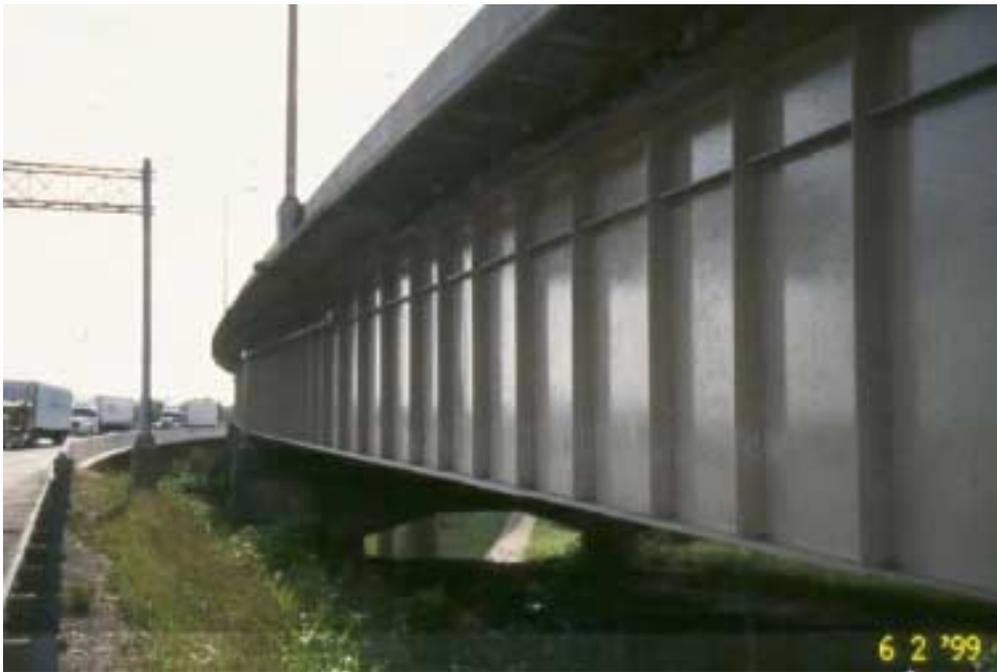
Figure 83. High gloss on north bound approach to Sherman Minton on span 14 in 1999.

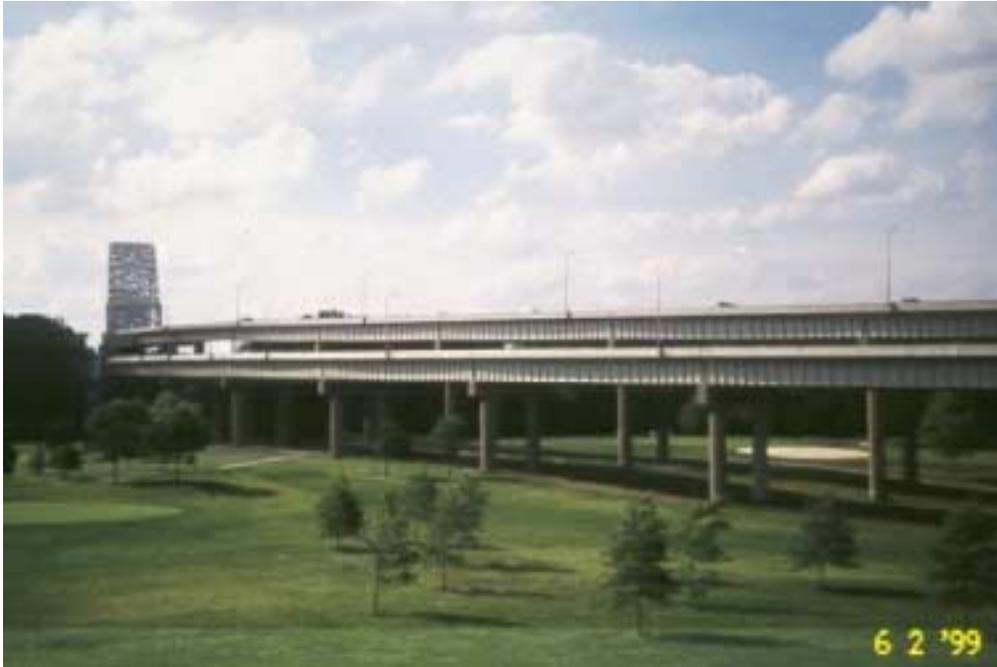
Figure 84. Completed east and westbound approaches of span 14 to the Sherman Minton Bridge in 1999.

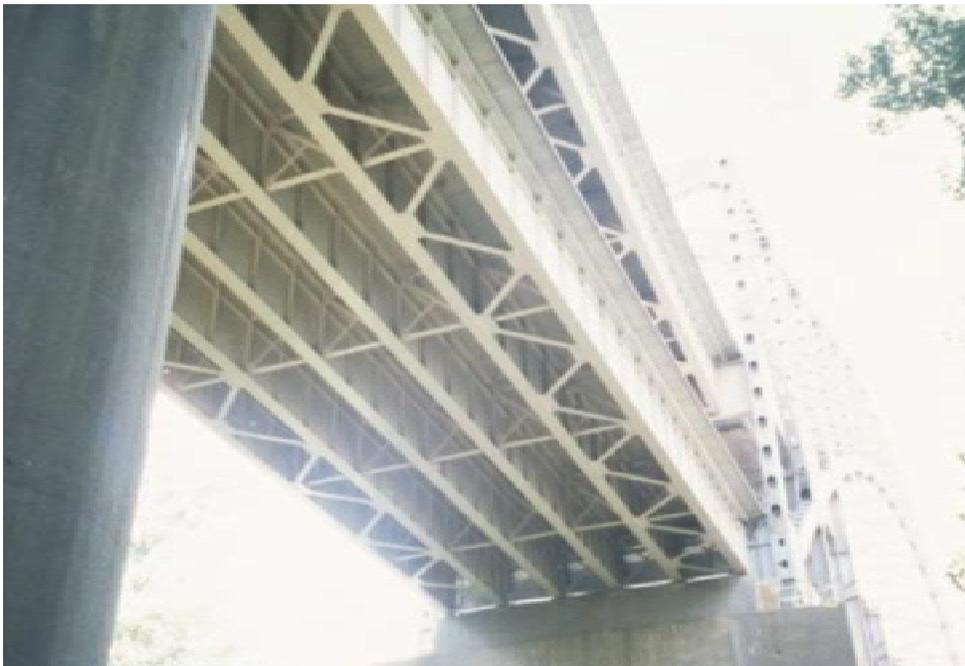
Figure 85. West most segment of span 14 at the east end of the Sherman Minton Bridge in 1999.
